# Manhole Inspection Summary

Manhole # S35M1\_010MH

**Location** Address: **201 Reedbird Ave**

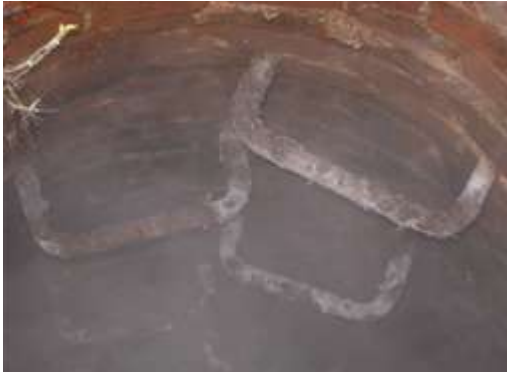
steps

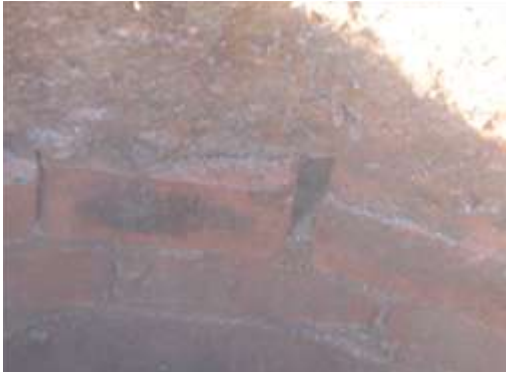
Defect 1

Condition: ☐ Sound ☐ Cracked ☐ Root Intrusion ☒ **Loose Brick** ☐ Deteriorated

loose brick on chimney

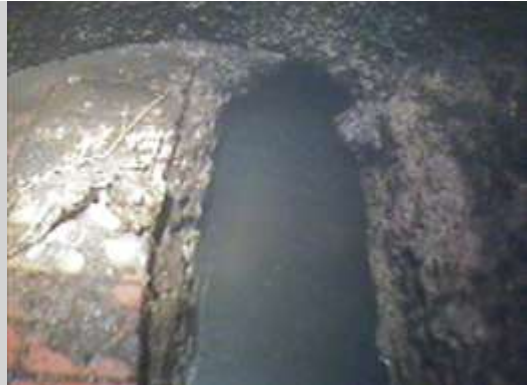
12 O'Clock Outflow

12 in. Circular Gravity Sewer  
Pipe Out @ 12 O'Clock

Pipe Height: **13.2** (in.) Rod and Bar (Angled)  
Pipe Material: **Clay** ☐ Pipe Lined  
Invert Depth: **12.84** (ft.) Flow Characteristics: **Fast**  
Deposits: ☒ None ☐ Mud ☐ Sludge ☐ Debris ☐ Grease  
Silt Depth: (in.) Deposits Extent:  
Infiltration: **None** Pipe Seal Cond: **Sound**

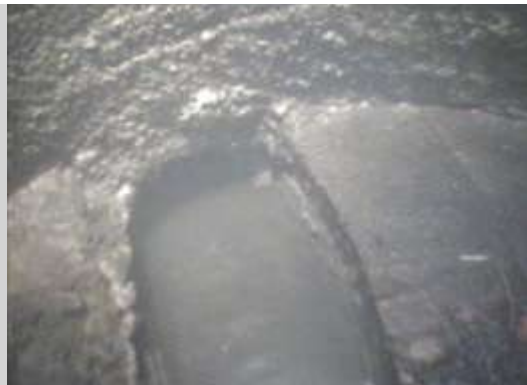
6 O'Clock Inflow

12 in. Circular Gravity Sewer  
Pipe In @ 6 O'Clock

Pipe Height: **13.2** (in.) Rod and Bar (Angled)  
Pipe Material: **Clay** ☐ Pipe Lined  
Invert Depth: **12.81** (ft.) Flow Characteristics: **Fast**  
Deposits: ☒ None ☐ Mud ☐ Sludge ☐ Debris ☐ Grease  
Silt Depth: (in.) Deposits Extent:  
Infiltration: **None** Pipe Seal Cond: **Sound**
